Re: Reconnaissance Inspection within the Autonomous Municipality of San Juan (MSJ) and Puerto Rico Aqueduct and Sewer Authority (PRASA) Collection Systems.  
Autonomous Municipality of San Juan (MSJ) MS4 (PRR040036)  
Puerto Rico Aqueduct and Sewer Authority (PRASA) Puerto Nuevo Wastewater Treatment Plant Collection System (PR0021555)

**SANTURCE'S RIBOT STREET STORM WATER AND WASTEWATER  
COLLECTION SYSTEMS**

Reconnaissance Inspection: Autonomous Municipality of San Juan (MSJ) Municipal Separate Storm Sewer System (MS4)  
National Pollutant Discharge Elimination System (NPDES) Permit (PRR040036)  
Puerto Rico Aqueduct and Sewer Authority ("PRASA") Puerto Nuevo Regional Wastewater Treatment Plant (RWWTP) NPDES Permit (PR0021555)

Inspection Date: January 23, 2015

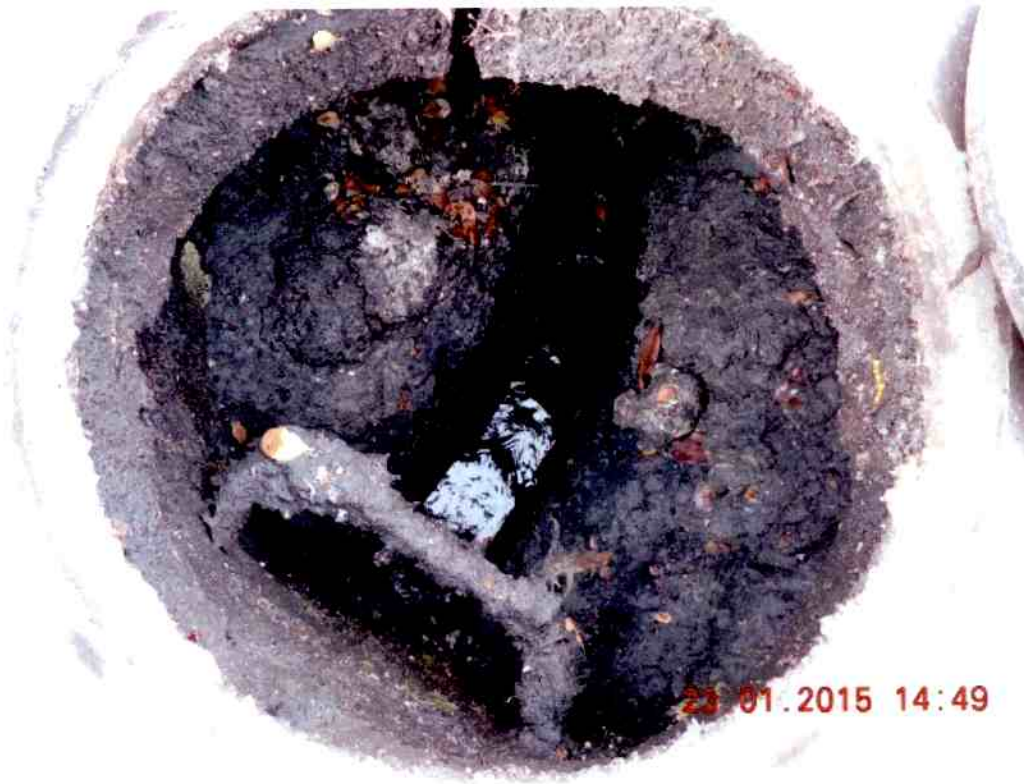
14. A wastewater manhole located south of Condado and Ribot Streets intersection was found flowing slowly but with signs of recent high levels and heavy accumulation of solids in the sides of the structure bottom. See photos DSCN1726 and 1727 for more details.

**DSCN1726** – Partial view of wastewater manhole located south of Condado and Ribot Streets intersection was found flowing slowly but with signs of recent high levels and heavy accumulation of solids in the sides of the structure bottom.

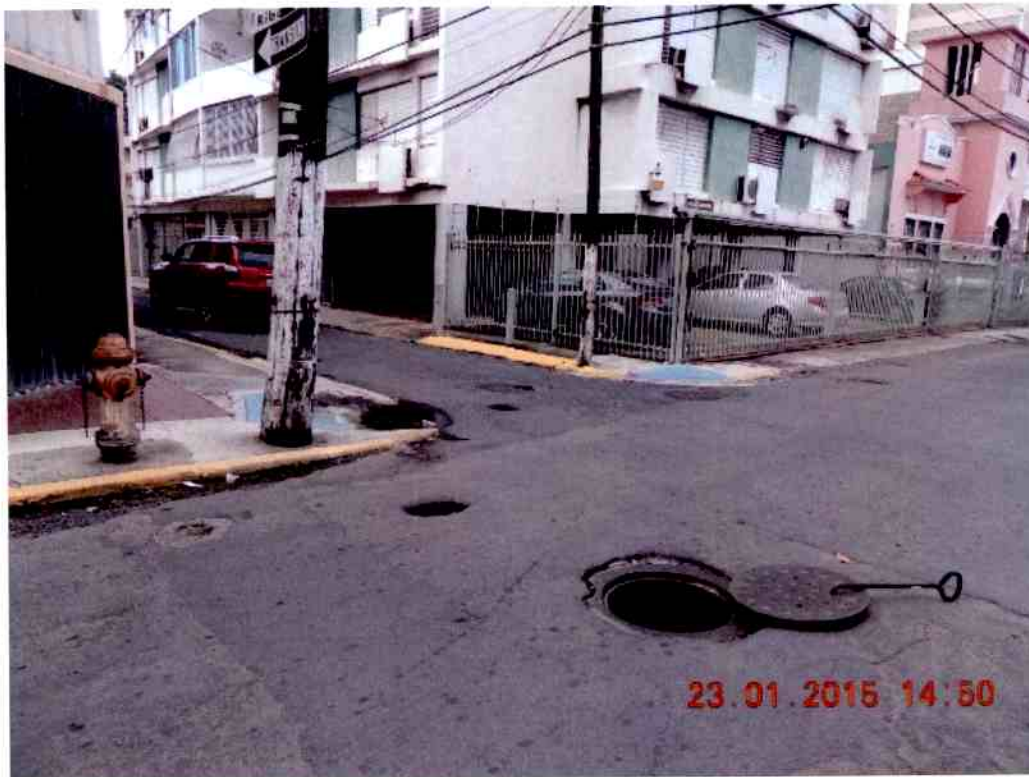
**DSCN1727** – View of south side of Ribot and Condado Streets intersection. The opened manhole in the photo is described in photo DSCN1726 above.
